TechConnect

Premature timing chain failure/crankshaft Reluctor ring movement

2006-2015 GM 3.6L Engines

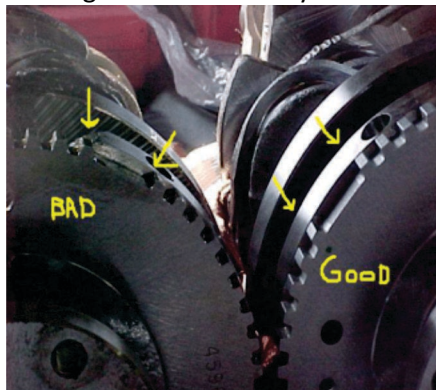
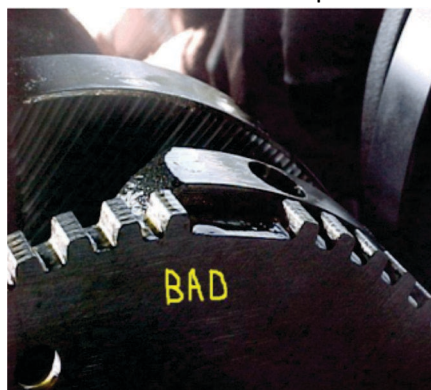
The 3.6L engine in the applicable model years is subject to timing chain stretch and crankshaft Reluctor ring movement causing trouble codes, engine surging and possibly an engine no start condition. A wide variety of trouble codes may set to include P0008, P009, P016, P017, P018, or P019. The timing chains and Reluctor wheel should be inspected whenever servicing these vehicles. In an initial service bulletin release by GM it was recommended to replace the crankshaft when the Reluctor wheel moved but GM has since released a replacement Reluctor wheel which would require specialized tools to replace.

The included photographs from GM service bulletin PIP3423 detail the problem visually, but the solution does become very in depth. The engine should be removed to ease the service of these engines. If the timing chains have slack beyond the specification it is recommended to replace all components associated with the timing chains. Poor oil change intervals can be an associated cause of these problems and it is possible other damage may have occurred within the motor. Engine replacement may be the safest solution to these vehicles. A motor oil analysis could detail the amount of steel particles in the engines lubrication system to aid in the correct method of repair.
